INTERMITTENT HEADACHES TRACKED TO HOSPITAL'S LOADING DOCK ACTIVITY

P-TRAK™ ULTRAFINE PARTICLE COUNTER CASE STUDY #1

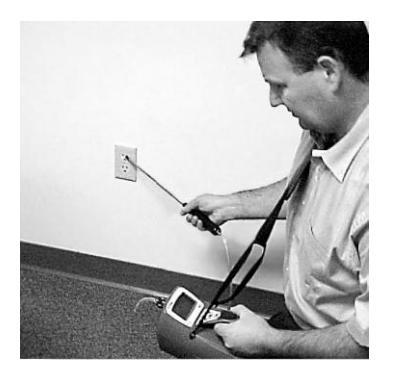
The investigation then focused on the doctor's office. Using the P-Trak[™] Ultrafine Particle Counter, maintenance quickly discovered UFP concentrations as high as 15,400 at an AC wall outlet. After covering the outlet with duct tape, the UFP reading in that office quickly dropped to match the adjacent offices.

Knowing that the electrical outlet was the source of the UFPs, building maintenance examined the building blueprints and found that the electrical conduit from the doctor's office led to a junction box, which then connected to a conduit that led to the loading dock. The early morning complaint could be easily correlated to vehicle activity in the loading dock. Maintenance sealed the ends of the conduits and the doctor's complaints ended.

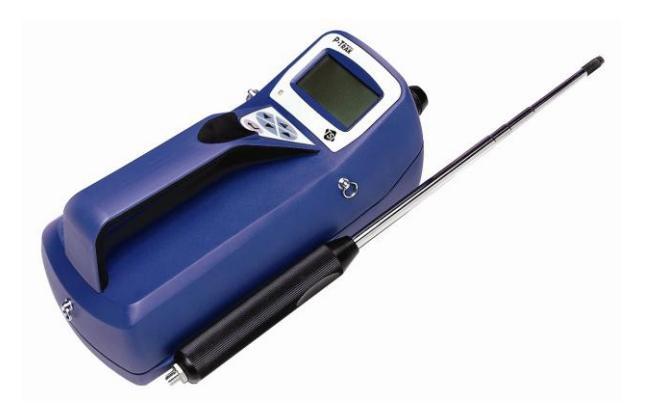
The P-Trak[™] Ultrafine Particle Counter uses fundamental measurement technology proven around the world in research and industrial applications since 1978. Its data logging feature allows the user to download field measurements for evaluation in TSI's TrakPro™ Data Analysis Software or in common word processing and spreadsheet programs, simplifying record keeping and reports.
