HVAC SYSTEM RECIRCULATES COPIER EMISSIONS

P-TRAK™ ULTRAFINE PARTICLE COUNTER CASE STUDY #8

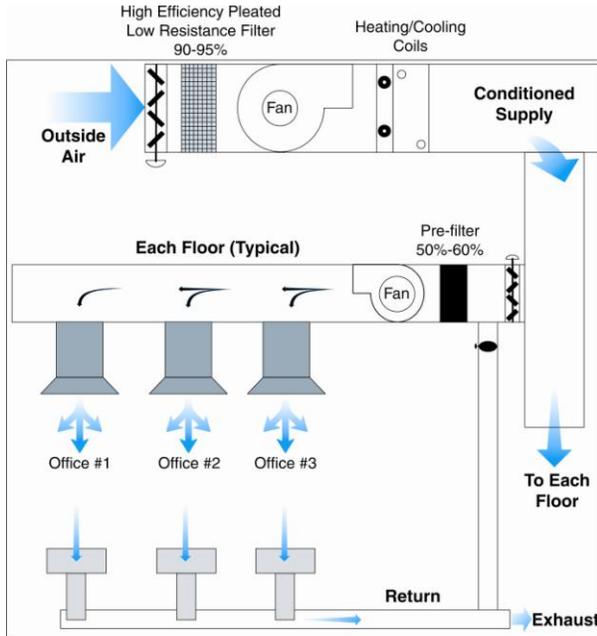
The investigator then surveyed the floor office by office to locate the actual source. He soon found that a malfunctioning photocopier was producing UFP levels near 150,000.

Once the copier was serviced, the investigator used the P-Trak™ Ultrafine Particle Counter to determine that UFP emissions from the copier were the same as the indoor goal. To prevent future occurrences, the building manager initiated a routine maintenance program that included regular UFP surveys with goals based on outside UFP levels and building filter efficiencies.

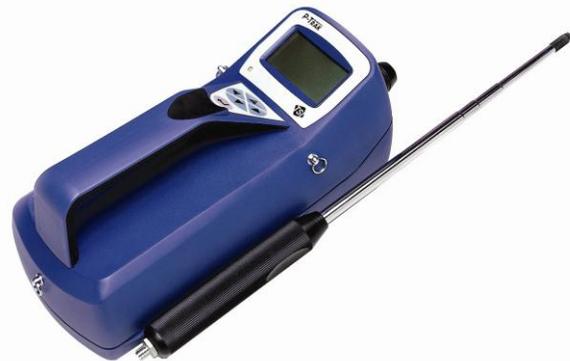
The P-Trak™ Ultrafine Particle Counter uses fundamental measurement technology proven around the world in research and industrial applications since 1978. Its data logging feature allows the user to download field measurements for evaluation in TSI's TrakPro™ Data Analysis Software or in common word processing and spreadsheet programs, simplifying record keeping and reports.
