# RESPIRATORY COMPLAINTS CLOUDED BY SMOKE THEN TRACED TO VACANT SPACE

P-TRAK™ ULTRAFINE PARTICLE COUNTER CASE STUDY #9

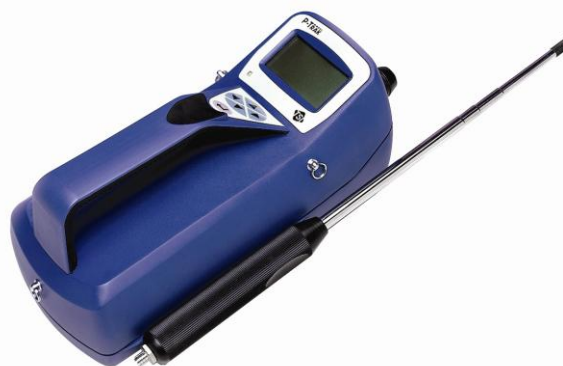
The P-Trak™ Ultrafine Particle Counter uses fundamental measurement technology proven around the world in research and industrial applications since 1978. Its data logging feature allows the user to download field measurements for evaluation in TSI's TrakPro™ Data Analysis Software or in common word processing and spreadsheet programs, simplifying record keeping and reports.

Tracking UFPs with the P-Trak™ Ultrafine Particle Counter is a new and effective method for identifying the root cause of problems. Targeting the true source, or sources, of unexpected ultrafine particle concentrations helps to clarify indoor air quality and other problems. Removing, repairing or controlling the source and shutting down pathways has been shown to effectively eliminate related complaints.
